CENTRAL INTELLIGENCE AGENCY

Port Information: Odessa

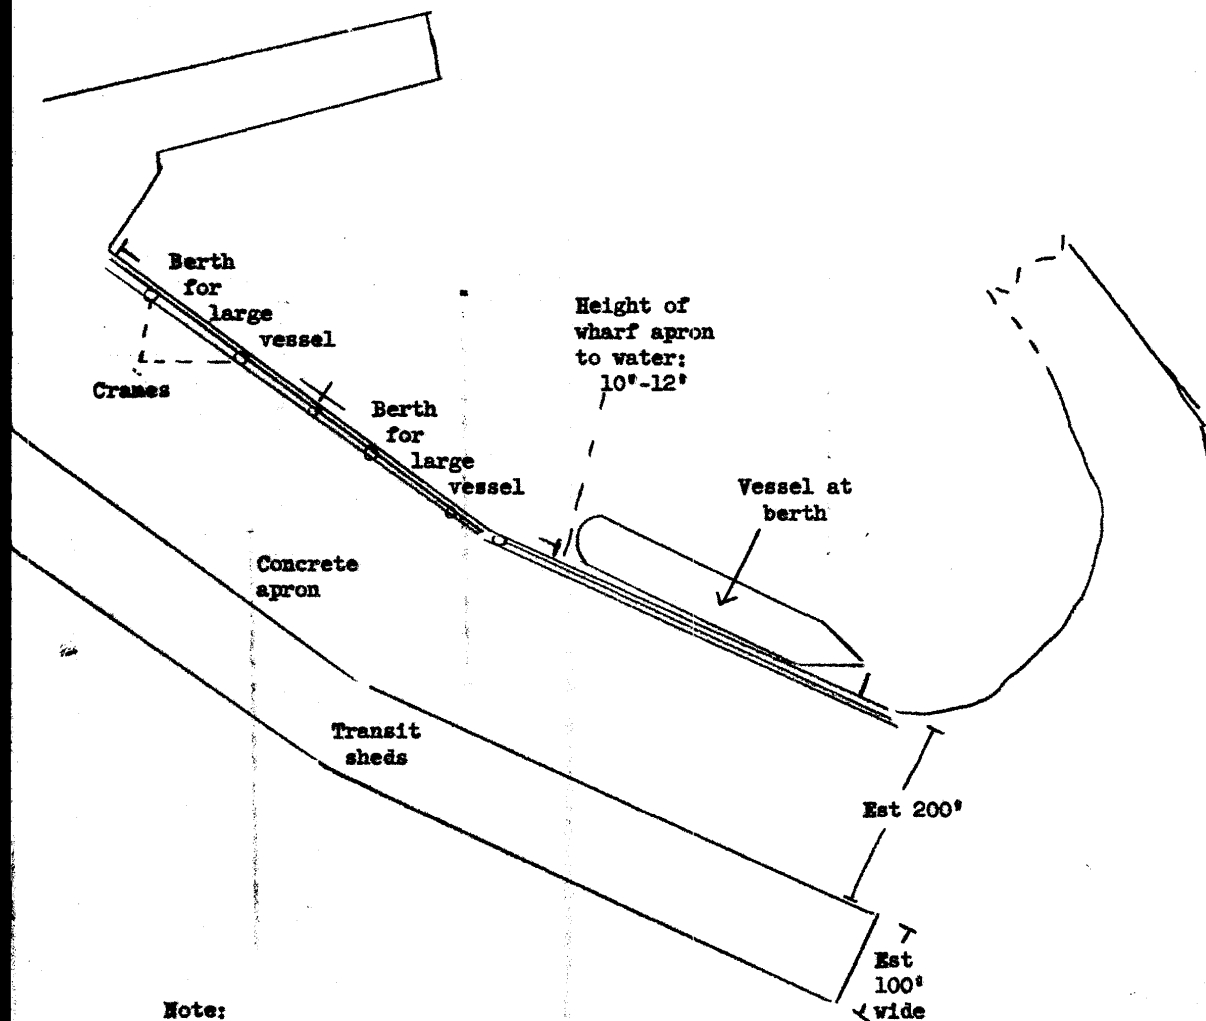
8. Berth [redacted] a diagram of berth and adjacent wharf area appears below:

Wharf was [redacted] constructed of concrete over stone, in excellent condition, and having fenders, with stringers set in, along entire length of wharf; height of wharf apron above surface of water was 10' to 12' (tidal range approximately 2'). No fire protection was evident on wharf area, and no water outlets were present nearer than transit sheds shown in diagram; nature and number of water outlets in transit sheds were not determined. Wharf area is accessible to truck but has no railroad spur tracks; only apparent means of transferring cargo from vessels to transit sheds is by truck, cart, or manual carry. Six electric hammerhead tower cranes with an estimated height of 50' to 60', total boom length 75' to 80', a 20-ton lift

2/3 distance from end of boom, and a 5-ton lift at end of boom; cranes were all-electric, appeared in excellent condition, and were used to good advantage by skilled male operators. Similar cranes were also observed in New Harbor and Cabotage Harbor, [redacted]

Transit sheds shown in diagram were described as being of mixed stone and brick construction with apparently a slate or composition-type roof, about 40° to 50° high, approximately 100° wide, and extending the entire length of the wharf as one apparently undivided long building. Similar sheds appeared to be present in each of the other inner harbor wharf areas, [redacted]

Both wharf apron and transit sheds were equipped with floodlights which appeared adequate to permit night work in these areas. [redacted]

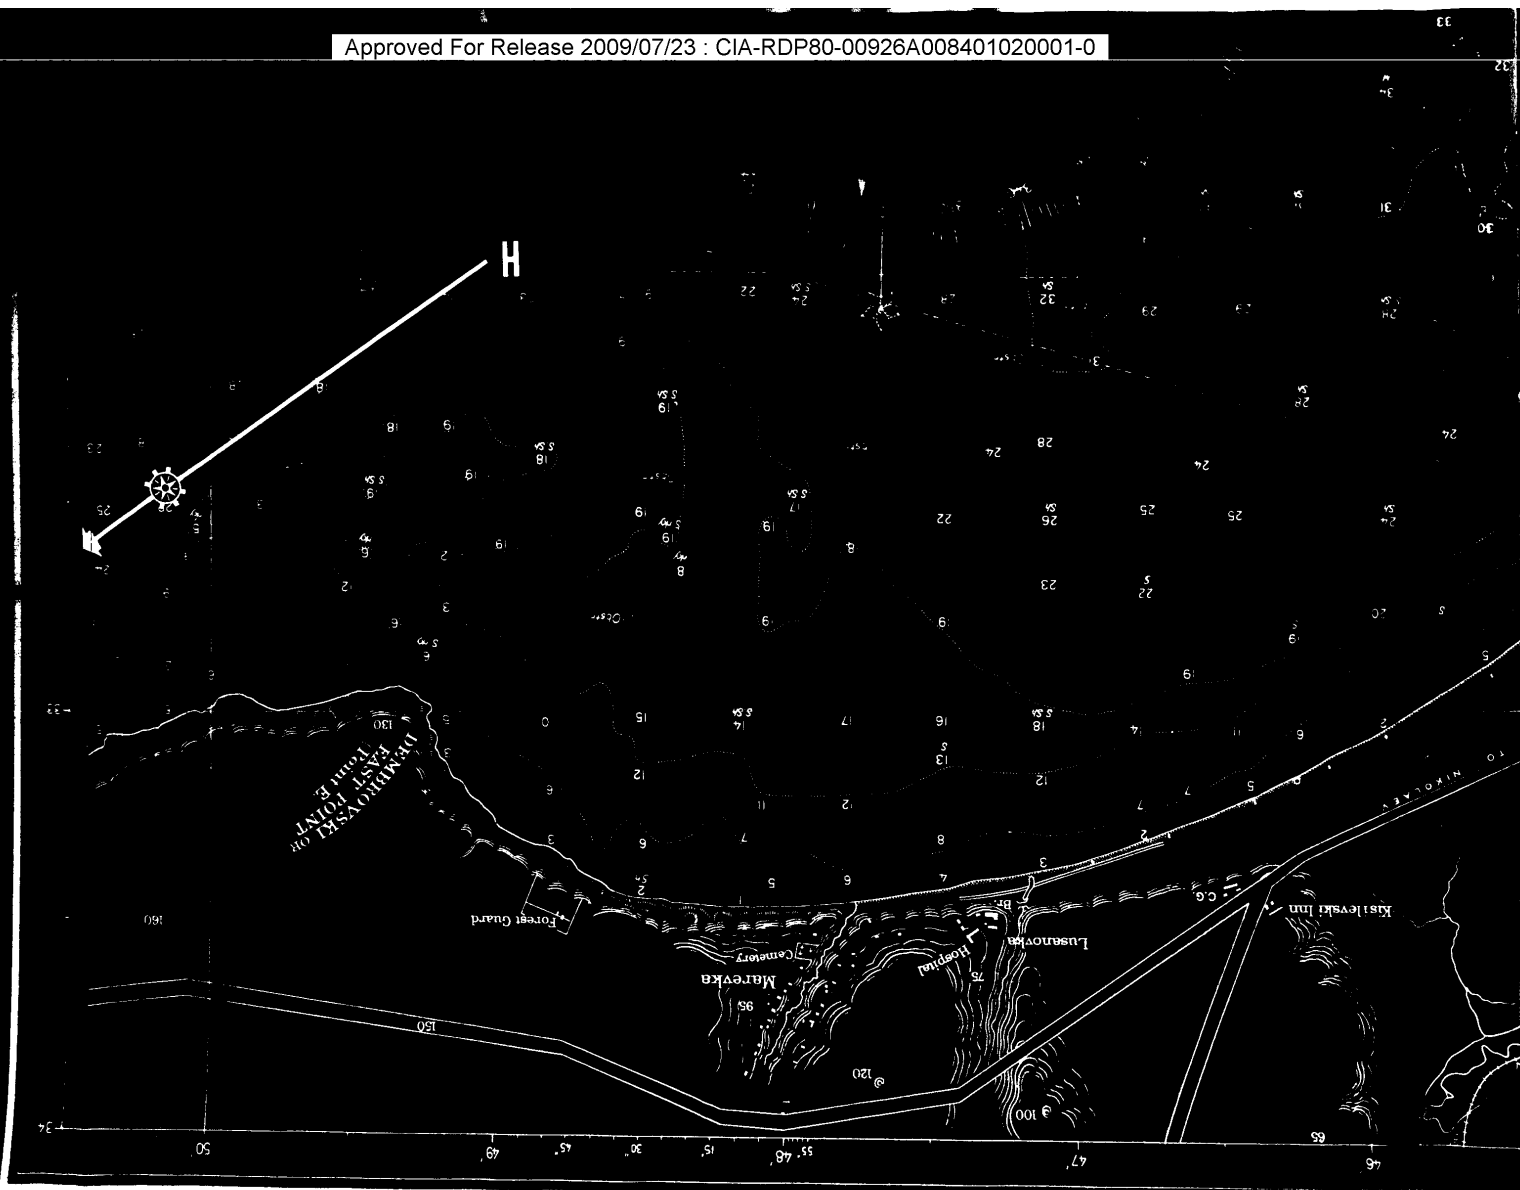
ODESSA HARBORS

From a Russian Government chart of 1931
Vorontsovski Light Lat. 46° 29' 46" N. Long. 30° 45' 39" E.
Natural Scale 1:50,000

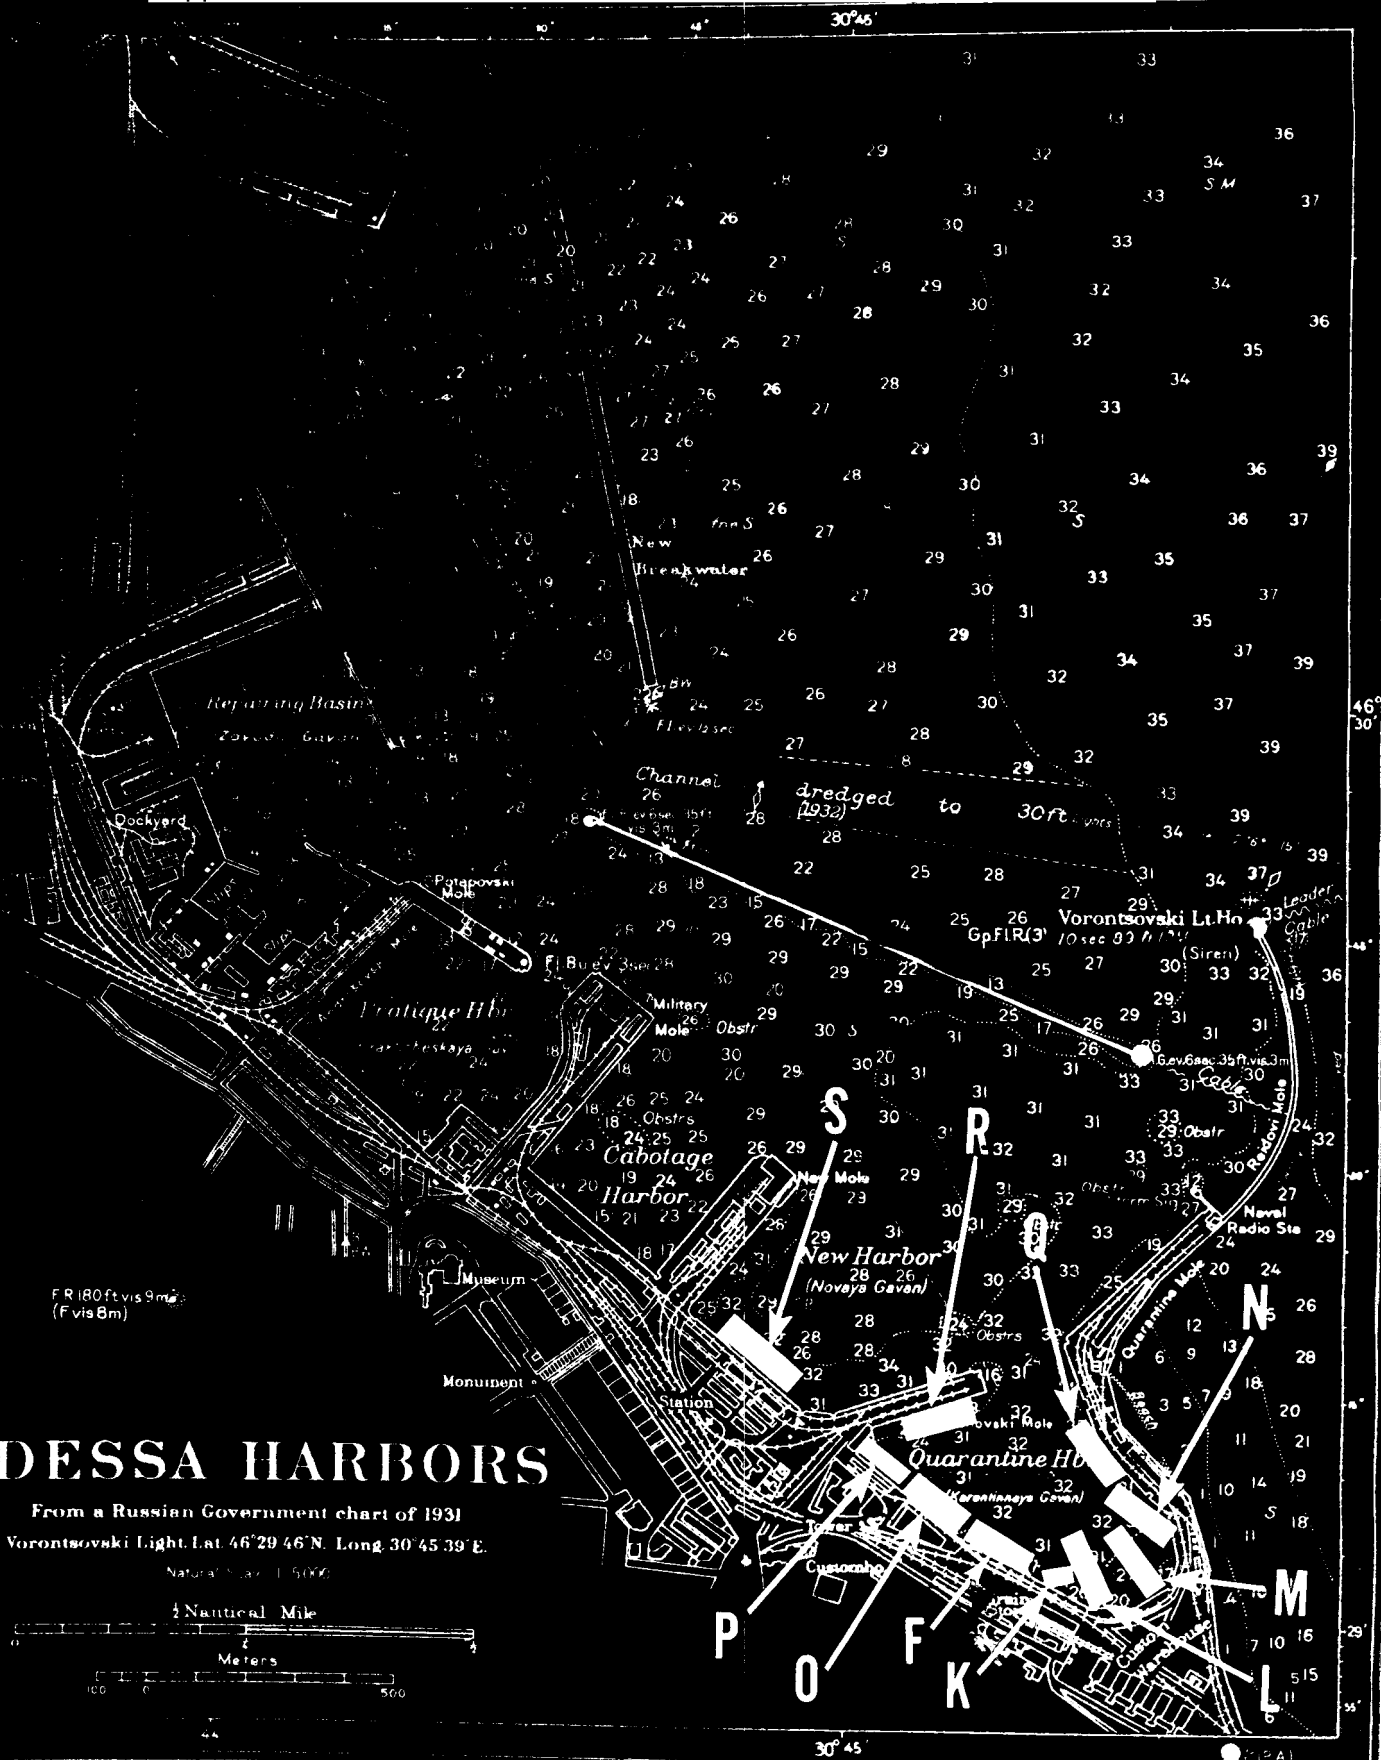
- A. Cape Fontan Light
B. Cape Fontan Radio Beacon NAVY Review Completed
C. Vorontsovski Light
D. Signal Station
E. Anchorage; Pilot and two Quarantine Officials aboard (arriving)

F. Berth
G. Pilot discharged (departing)
H. Searchlight battery bearing 055°T from E
I. Searchlight battery bearing 181°T from E
J. Searchlight battery bearing 315°T from E

K. Floating Crane
L. Merchant freighter, Soviet registry about eight thousand gross tons; under repair
M. Merchant freighter, Soviet registry about eight thousand gross tons; under repair
